**Flood Control Project Maintenance  
Levee Inspections****LMA District Cover Sheet****Spring 2014 Levee Inspection Results****Butte County Department of Public Works**

**Levee Inspection Report By Mile - Spring 2014**

Waterway	Bank	Unit Miles	Inspection Start/End	Inspector
Unit No. 01 Mud Creek	Right	7.29	04/10/2014 04/10/2014	Bob Duffey

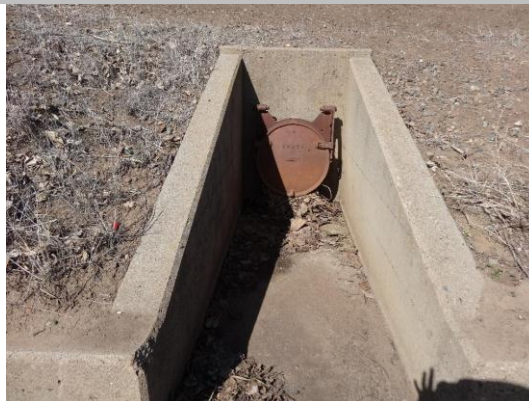
Photo 1 of 1 : UCIP\_6042.jpg

LM Start	1.02	Rating **	M	Issue No.	12
LM End	1.02	Issue Type +	En	Location *	LS
Category	Supplemental			GPS Latitude/Longitude	
				Start	End
Item	DWR UCIP Field Study			39.739268 °	39.739268 °
				-121.931891 °	-121.931891 °
DWR ID	DWR_NA0003_01_s_2014_12				
Action/Comments					
Inspector Comments: FS_ID:29706					
EP_NO: N/A					
Repair Type:					
Crossing Status:					
UCIP Comments: Vegetation debris on waterside. Needs clearing and cleaning.					
FIELD_STRUCT_DESC: 24-inch CM pipe through the levee, 12.0 feet below the crown. Flap gate on the waterward end. Concrete "U" headwalls on both ends. Grouted riprap apron on the landward end. Grouted riprap apron on the landward end. Grouted riprap spillway on the waterward end. O&M Manual Sac 504, May 1965.					
FS Date: 2/20/2014

WS view: U typed concrete headwall, pipe, and flapgate on levee slope.

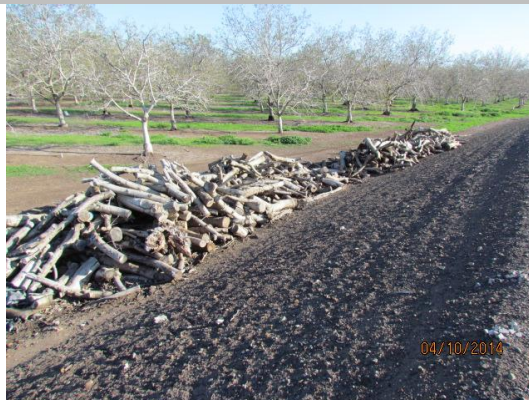
Photo 1 of 1 : rduffey\_s\_20140428\_194.jpg

LM Start	1.74	Rating **	M	Issue No.	15
LM End	1.74	Issue Type +	En	Location *	LS
Category	Earthen Levee			GPS Latitude/Longitude	
				Start	End
Item	Encroachments			39.745718 °	39.745718 °
				-121.923124 °	-121.923124 °
DWR ID	DWR_NA0003_01_s_2014_15				
Action/Comments					
Firewood

View of the firewood along the landside toe.

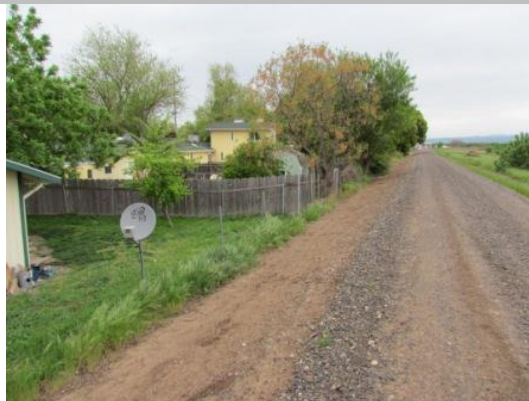
Photo 1 of 1 : rduffey\_s\_20140304\_517.jpg

LM Start	2.06	Rating **	U	Issue No.	3
LM End	2.10	Issue Type +	En	Location *	LS
Category	Earthen Levee			GPS Latitude/Longitude	
				Start	End
Item	Encroachments			39.748330 °	39.748867 °
				-121.918685 °	-121.918533 °
DWR ID	DWR_NA0003_01_s _ 2012_3				
Action/Comments					
Fence

View of the fences along the L/S toe.

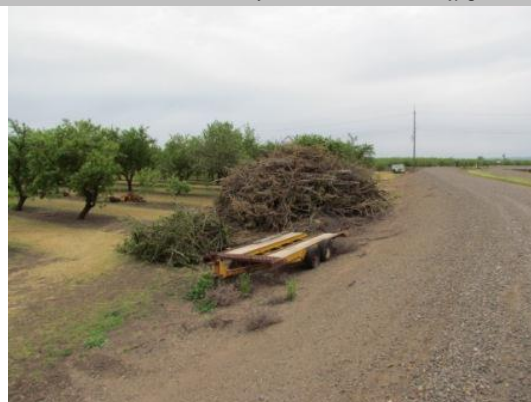
Photo 1 of 1 : rduffey\_s\_20140304\_516.jpg

LM Start	3.00	Rating **	M	Issue No.	1
LM End	3.00	Issue Type +	Ma	Location *	LS
Category	Earthen Levee			GPS Latitude/Longitude	
				Start	End
Item	Encroachments			39.759755 °	39.759755 °
				-121.911160 °	-121.911160 °
DWR ID	DWR_NA0003_01_s_2012_1				
Action/Comments					
Prunings

View of the pruning pile along the L/S toe.

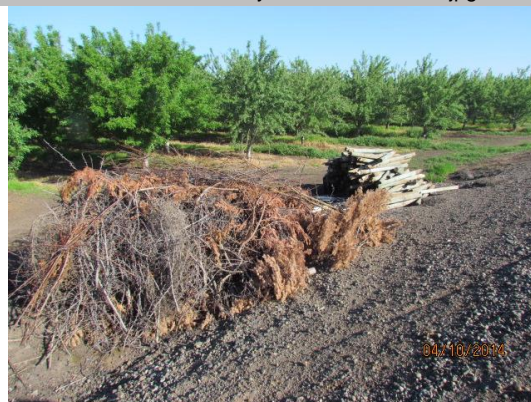
Photo 1 of 1 : rduffey\_s\_20140428\_196.jpg

LM Start	3.10	Rating **	M	Issue No.	25
LM End	3.10	Issue Type +	Ma	Location *	LS
Category	Earthen Levee			GPS Latitude/Longitude	
				Start	End
Item	Encroachments			39.761085 °	39.761085 °
				-121.911048 °	-121.911048 °
DWR ID	DWR_NA0003_01_s_2012_25				
Action/Comments					
Prunings

View of the prunings along the landside toe.

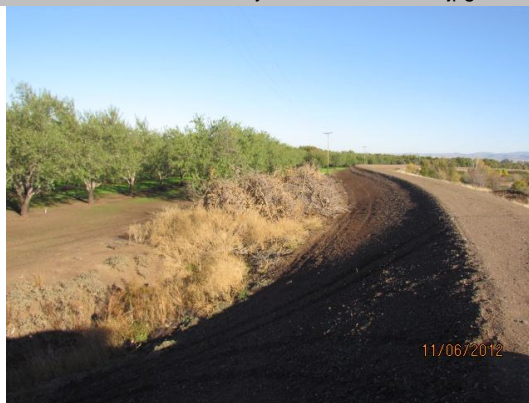
Photo 1 of 1 : rduffey\_s\_20140304\_521.jpg

LM Start	4.58	Rating **	M	Issue No.	21
LM End	4.58	Issue Type +	Ma	Location *	LS
Category	Earthen Levee			GPS Latitude/Longitude	
				Start	End
Item	Encroachments			39.775908 °	39.775908 °
				-121.893947 °	-121.893947 °
DWR ID	DWR_NA0003_01_s _ 2012_21				
Action/Comments					
Prunings

View of the brush pile along landside toe.

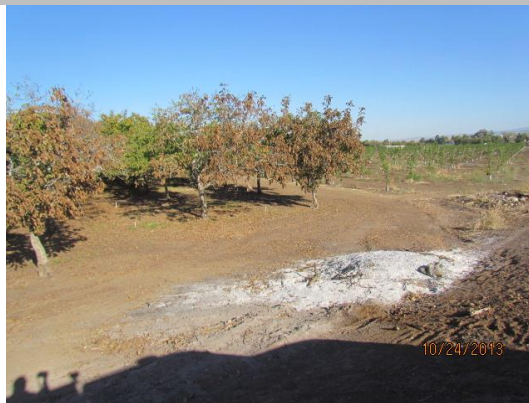
Photo 1 of 1 : rduffey\_s\_20140304\_519.jpg

LM Start	4.91	Rating **	M	Issue No.	13
LM End	4.91	Issue Type +	En	Location *	LS
Category	Earthen Levee			GPS Latitude/Longitude	
				Start	End
Item	Encroachments			39.780068 °	39.780068 °
				-121.891469 °	-121.891469 °
DWR ID	DWR_NA0003_01_s _ 2013_13				
Action/Comments					
Prunings

The landowner burned the pruning pile.

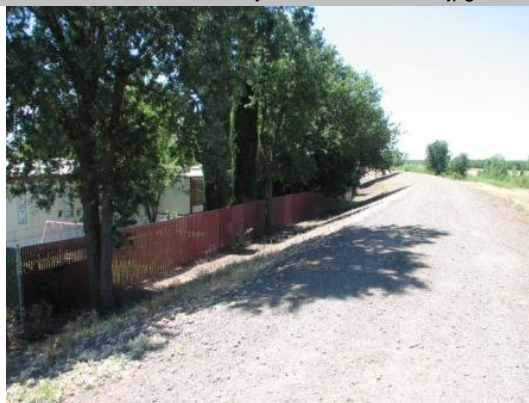
Photo 1 of 1 : rduffey\_s\_20140304\_524.jpg

LM Start	1.58	Rating **	U	Issue No.	3
LM End	1.90	Issue Type +	En	Location *	LS
Category	Earthen Levee			GPS Latitude/Longitude	
				Start	End
Item	Encroachments			39.782773 °	39.778972 °
				-121.888178 °	-121.891563 °
DWR ID	DWR_NA0003_02_s_2012_3				
Action/Comments					
Fence

View of the fence along the landside toe of the levee.

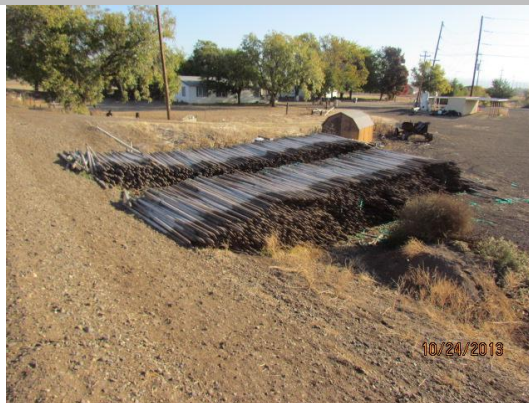
Photo 1 of 1 : rduffey\_s\_20140304\_523.jpg

LM Start	2.90	Rating **	M	Issue No.	1
LM End	2.90	Issue Type +	En	Location *	LS
Category	Earthen Levee			GPS Latitude/Longitude	
				Start	End
Item	Encroachments			39.767841 °	39.767841 °
				-121.901534 °	-121.901534 °
DWR ID	DWR_NA0003_02_f_2013_1				
Action/Comments					
Material

View of the tree stakes along the landside slope and toe.

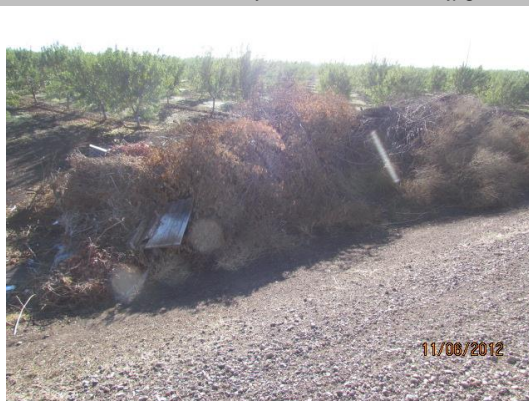
Photo 1 of 1 : rduffey\_s\_20140304\_525.jpg

LM Start	3.42	Rating **	M	Issue No.	5
LM End	3.42	Issue Type +	Ma	Location *	LS
Category	Earthen Levee			GPS Latitude/Longitude	
				Start	End
Item	Encroachments			39.763208 °	39.763208 °
				-121.908517 °	-121.908517 °
DWR ID	DWR_NA0003_02_f_2012_5				
Action/Comments					
Prunings

View of the brush pile along landside toe.

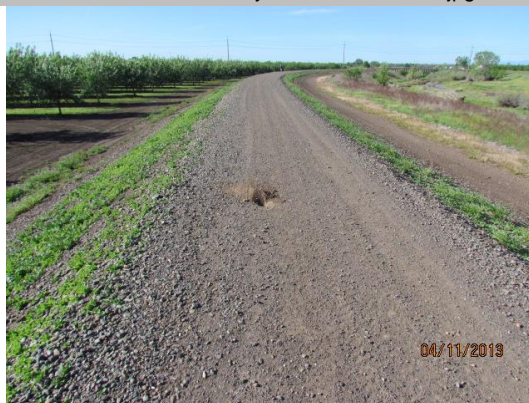
Photo 1 of 1 : rduffey\_s\_20140304\_526.jpg

LM Start	3.45	Rating **	M	Issue No.	6
LM End	3.45	Issue Type +	Ma	Location *	CR
Category	Earthen Levee			GPS Latitude/Longitude	
				Start	End
Item	Animal Control			39.762853 °	39.762853 °
				-121.908653 °	-121.908653 °
DWR ID	DWR_NA0003_02_s _ 2013_6				
Action/Comments					
No rodents visible, but rodent burrows visible; need to backfill and compact or grout burrows.

View of the rodent hole in the crown roadway.

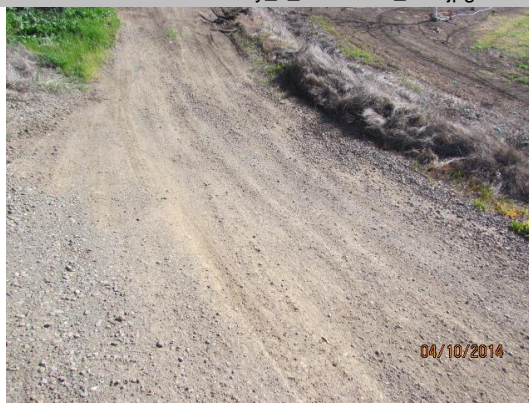
Photo 1 of 1 : rduffey\_s\_20140428\_199.jpg

LM Start	3.63	Rating **	M	Issue No.	10
LM End	3.63	Issue Type +	Ma	Location *	LS
Category	Earthen Levee			GPS Latitude/Longitude	
				Start	End
Item	Slope Stability			39.760531 °	39.760531 °
				-121.910293 °	-121.910293 °
DWR ID	DWR_NA0003_02_s _ 2014_10				
Action/Comments					
Repair the levee slope damaged by vehicle traffic and prevent access where possible.

View of the vehicle erosion along the waterside slope.

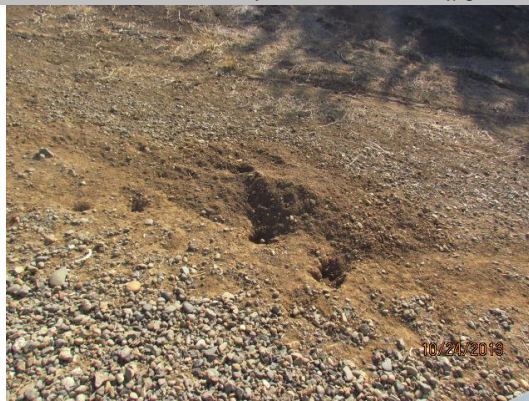
Photo 1 of 1 : rduffey\_s\_20140304\_528.jpg

LM Start	4.70	Rating **	A/W	Issue No.	8
LM End	4.70	Issue Type +	Ma	Location *	LS
Category	Earthen Levee			GPS Latitude/Longitude	
				Start	End
Item	Animal Control			39.749639 °	39.749639 °
				-121.917188 °	-121.917188 °
DWR ID	DWR_NA0003_02_f _ 2013_8				
Action/Comments					
Exterminate rodents and backfill and compact or grout burrows.

View of the rodent holes along the landside slope.

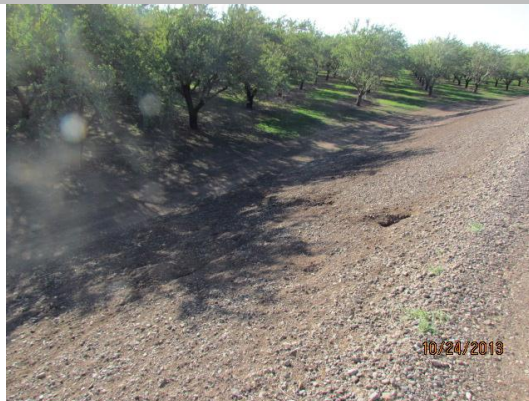
Photo 1 of 1 : rduffey\_s\_20140304\_529.jpg

LM Start	5.59	Rating **	A/W	Issue No.	9
LM End	5.59	Issue Type +	Ma	Location *	LS
Category	Earthen Levee			GPS Latitude/Longitude	
				Start	End
Item	Animal Control			39.740508 °	39.740508 °
				-121.926814 °	-121.926814 °
DWR ID	DWR_NA0003_02_f_2013_9				
Action/Comments					
No rodents visible, but rodent burrows visible; need to backfill and compact or grout burrows.

View of the rodent holes along the landside slope.

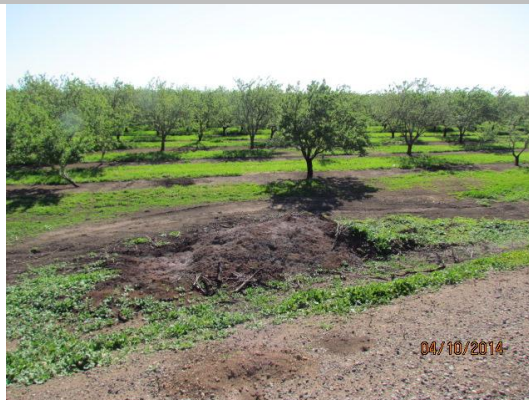
Photo 1 of 1 : rduffey\_s\_20140428\_200.jpg

LM Start	6.02	Rating **	M	Issue No.	7
LM End	6.02	Issue Type +	En	Location *	LS
Category	Earthen Levee			GPS Latitude/Longitude	
				Start	End
Item	Encroachments			39.736652 °	39.736652 °
				-121.932053 °	-121.932053 °
DWR ID	DWR_NA0003_02_s_2013_7				
Action/Comments					
Prunings

View of the removed prunings from the landside toe.

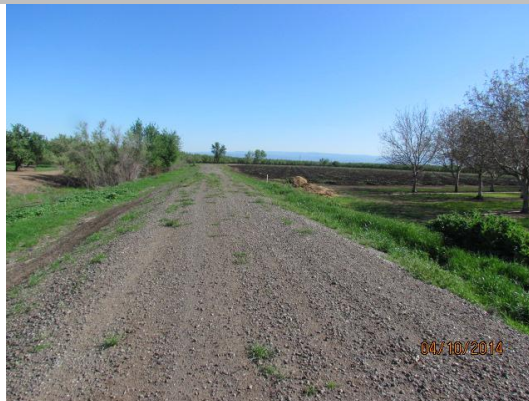
Photo 1 of 1 : rduffey\_s\_20140428\_201.jpg

LM Start	0.15	Rating **	A	Issue No.	3
LM End	0.15	Issue Type +	Ma	Location *	LS
Category	Earthen Levee			GPS Latitude/Longitude	
				Start	End
Item	Vegetation			39.734976 °	39.734976 °
				-121.929180 °	-121.929180 °
DWR ID	DWR_NA0003_02A_s_2014_3				
Action/Comments					
Control annual grass and weeds on the levee slopes and easements.

View of the native grasses on both slopes.

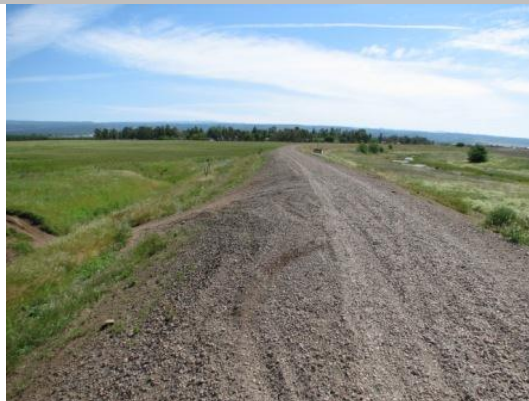
Photo 1 of 1 : rduffey\_s\_20140304\_530.jpg

LM Start	0.06	Rating **	M	Issue No.	3
LM End	0.06	Issue Type +	Ma	Location *	WS
Category	Earthen Levee			GPS Latitude/Longitude	
				Start	End
Item	Slope Stability			39.786068 °	39.786068 °
				-121.881828 °	-121.881828 °
DWR ID	DWR_NA0003_03_s _ 2012_3				
Action/Comments					
Repair the levee slope damaged by vehicle traffic and prevent access where possible.

View of the motorcycle erosion on the landside slope of the levee.

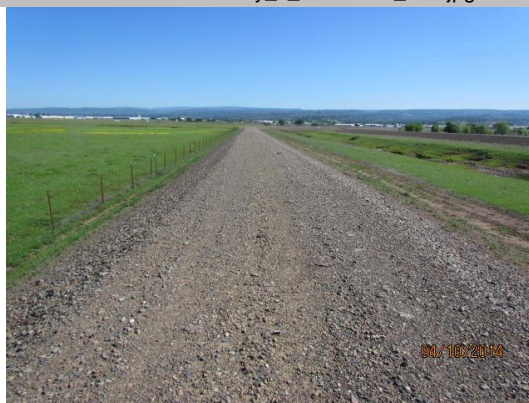
Photo 1 of 1 : rduffey\_s\_20140428\_202.jpg

LM Start	1.83	Rating **	A	Issue No.	4
LM End	1.83	Issue Type +	Ma	Location *	LS
Category	Earthen Levee			GPS Latitude/Longitude	
				Start	End
Item	Vegetation			39.780011 °	39.780011 °
				-121.852629 °	-121.852629 °
DWR ID	DWR_NA0003_03_s _ 2014_4				
Action/Comments					
Control annual grass and weeds on the levee slopes and easements.

View of the native grasses on both slopes.

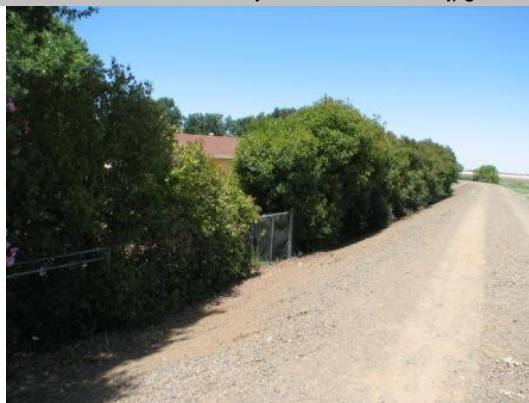
Photo 1 of 1 : rduffey\_s\_20140304\_531.jpg

LM Start	0.98	Rating **	U	Issue No.	1
LM End	1.05	Issue Type +	En	Location *	LS
Category	Earthen Levee			GPS Latitude/Longitude	
				Start	End
Item	Encroachments			39.776013 °	39.776595 °
				-121.851175 °	-121.852005 °
DWR ID	DWR_NA0003_04_s_2012_1				
Action/Comments					
Fence

View of the fence and trees along the landside toe of the levee.

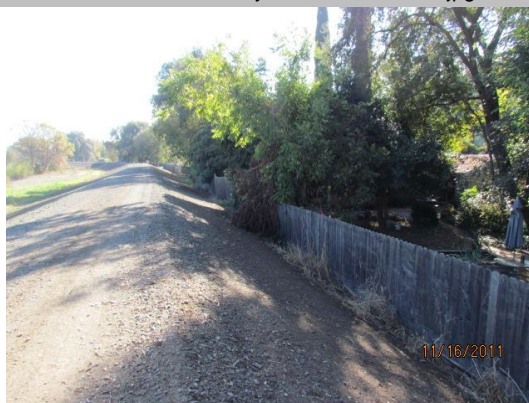
Photo 1 of 1 : rduffey\_s\_20140304\_533.jpg

LM Start	1.16	Rating **	U	Issue No.	3
LM End	1.27	Issue Type +	En	Location *	LS
Category	Earthen Levee			GPS Latitude/Longitude	
				Start	End
Item	Encroachments			39.776760 °	39.777650 °
				-121.854022 °	-121.855687 °
DWR ID	DWR_NA0003_04_s_2012_3				
Action/Comments					
Fence

View of the fence along the L/S toe.

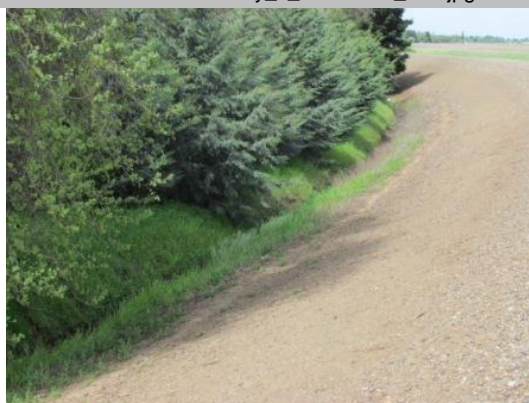
Photo 1 of 1 : rduffey\_s\_20140304\_532.jpg

LM Start	1.32	Rating **	M	Issue No.	2
LM End	1.40	Issue Type +	En	Location *	LS
Category	Earthen Levee			GPS Latitude/Longitude	
				Start	End
Item	Encroachments			39.778003 °	39.778378 °
				-121.856403 °	-121.857953 °
DWR ID	DWR_NA0003_04_s_2012_2				
Action/Comments					
Ditch

View of AG ditch at the L/S toe.

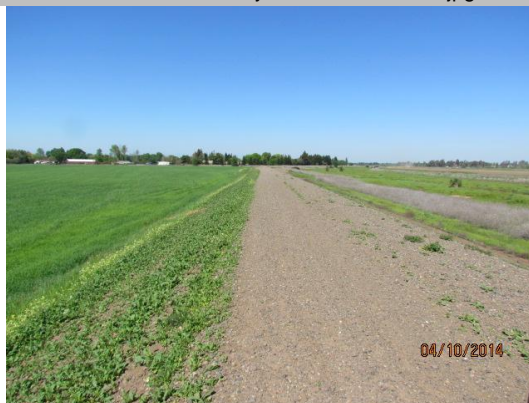
Photo 1 of 1 : rduffey\_s\_20140428\_203.jpg

LM Start	1.68	Rating **	A	Issue No.	6
LM End	1.68	Issue Type +	Ma	Location *	LS
Category	Earthen Levee			GPS Latitude/Longitude	
				Start	End
Item	Vegetation			39.778856 °	39.778856 °
				-121.862986 °	-121.862986 °
DWR ID	DWR_NA0003_04_s _ 2014_6				
Action/Comments					
Control annual grass and weeds on the levee slopes and easements.

View of the native grasses on both slopes.

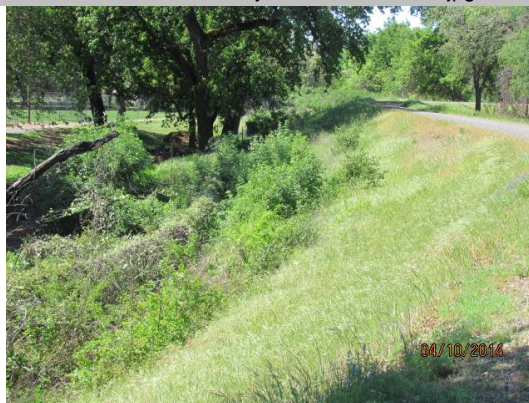
Photo 1 of 1 : rduffey\_s\_20140428\_204.jpg

LM Start	0.34	Rating **	M	Issue No.	3
LM End	0.42	Issue Type +	Ma	Location *	LS
Category	Earthen Levee			GPS Latitude/Longitude	
				Start	End
Item	Vegetation			39.761633 °	39.761117 °
				-121.795155 °	-121.796464 °
DWR ID	DWR_NA0003_05_f _ 2013_3				
Action/Comments					
Remove the wild growth other than native grasses from the levee slopes.

View of the vegetation along the landside slope and toe.

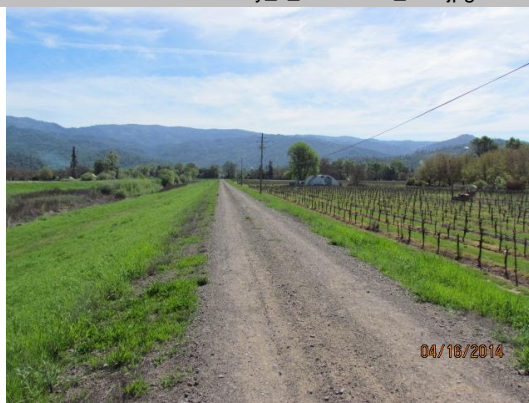
Photo 1 of 1 : rduffey\_s\_20140421\_178.jpg

LM Start	0.83	Rating **	A	Issue No.	4
LM End	0.83	Issue Type +	Ma	Location *	LS
Category	Earthen Levee			GPS Latitude/Longitude	
				Start	End
Item	Vegetation			39.763705 °	39.763705 °
				-121.802718 °	-121.802718 °
DWR ID	DWR_NA0003_05_s _ 2014_4				
Action/Comments					
Control annual grass and weeds on the levee slopes and easements.

View of the native grasses on both slopes.
